Manhole Inspection Summary

Manhole # S35AA1007MH

Insp Date: **3/26/07 8:54 AM**

Location Address: **110 34TH ST**

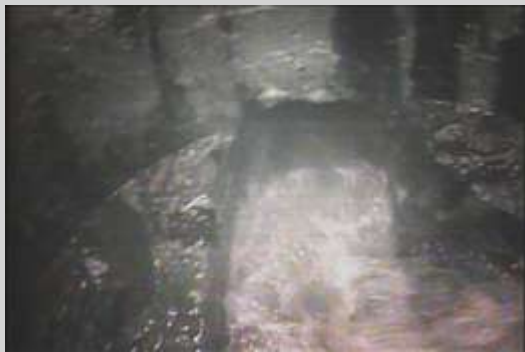
15 in. Circular Gravity Sewer Pipe Out @ 12 O'Clock

Pipe Material: **Clay** ☐ Pipe Lined

Invert Depth: **19.06** (ft.) Flow Characteristics: **Fast**

Infiltration: **None** Pipe Seal Cond: **Unknown**

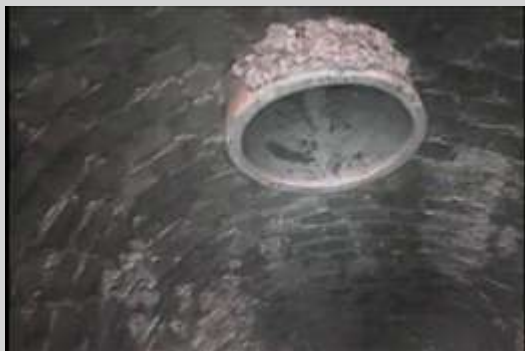
12 in. Circular Gravity Sewer Pipe In @ 3 O'Clock

Pipe Material: **Clay** ☐ Pipe Lined

Invert Depth: **10.94** (ft.) Flow Characteristics: **Turbulent**

Infiltration: **None** Pipe Seal Cond: **Unknown**

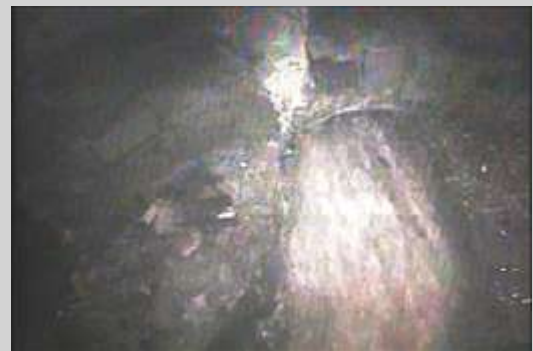
Drop In @ 3 O'Clock

Drop: **Outside** Rod and Bar

Angled: **Yes** Reading: **17.22** (ft.)

Inv Depth: **18.22** (ft.)

Drop Condition: **Open**

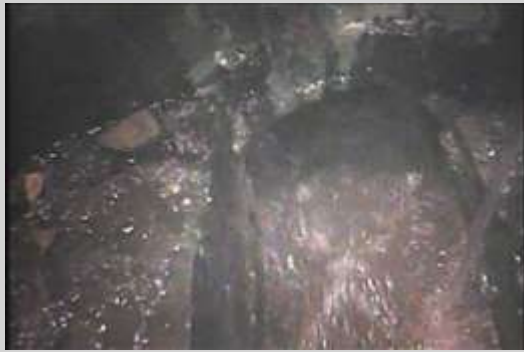
Pipe In @ 6 O'Clock

Pipe Material: **Clay** ☐ Pipe Lined

Infiltration: **None** Pipe Seal Cond: **Unknown**
